### 5TH FLOOR BOILER HOUSE SECTION VII ROOMS 7.06H

**Non-TCRA Building Assessment  
Avtex Fibers Superfund Site**

## POLYMER PLANT 5TH FLOOR SECTION I

ROOM 1.05 F

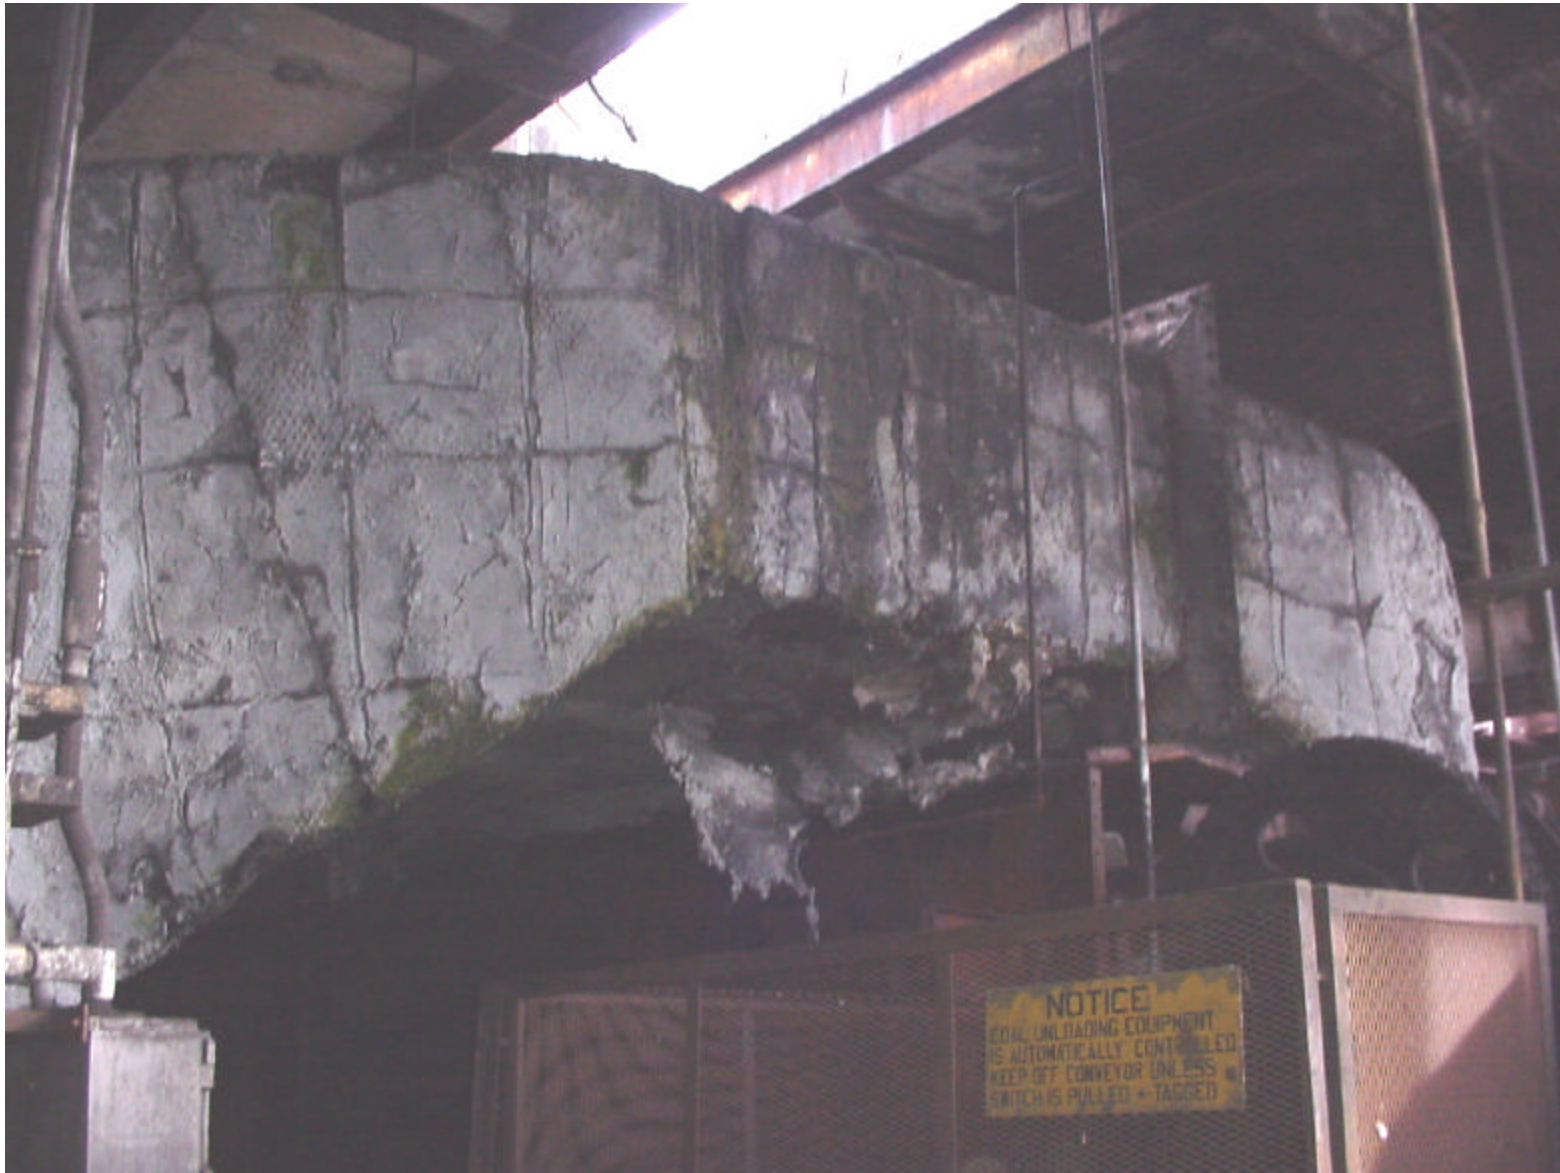
Room Size (ft):	Width	<u>180 ft</u>	Length	<u>115 ft</u>	Height	<u>20 ft</u>
Structural Concerns:	Y/N	<u>Large hole in roof over the SW corner of the room.</u>				
Subgrade features:	Y/N	<u>No</u>	Description			
Equipment:	Process	<u>No</u>	Nonprocess	<u>Yes</u>	Dry/Liq. <u>dry</u>	Debris Vol. <u>100 cu yd</u>
Tank/containers:	Y/N	<u>No</u>	Size/Vol.			
Piping:	Est. LF	<u>2,500</u>	Diam.	<u>6-8"</u>	Contents	<u>unknown - PACM wrapping</u>

Photograph ID	Date Taken	Section #	Room #	Room Description	Description
MVC-700		VII	7.06H	5th Floor Boiler House	Center of room facing west - <b>Note</b> hole in roof

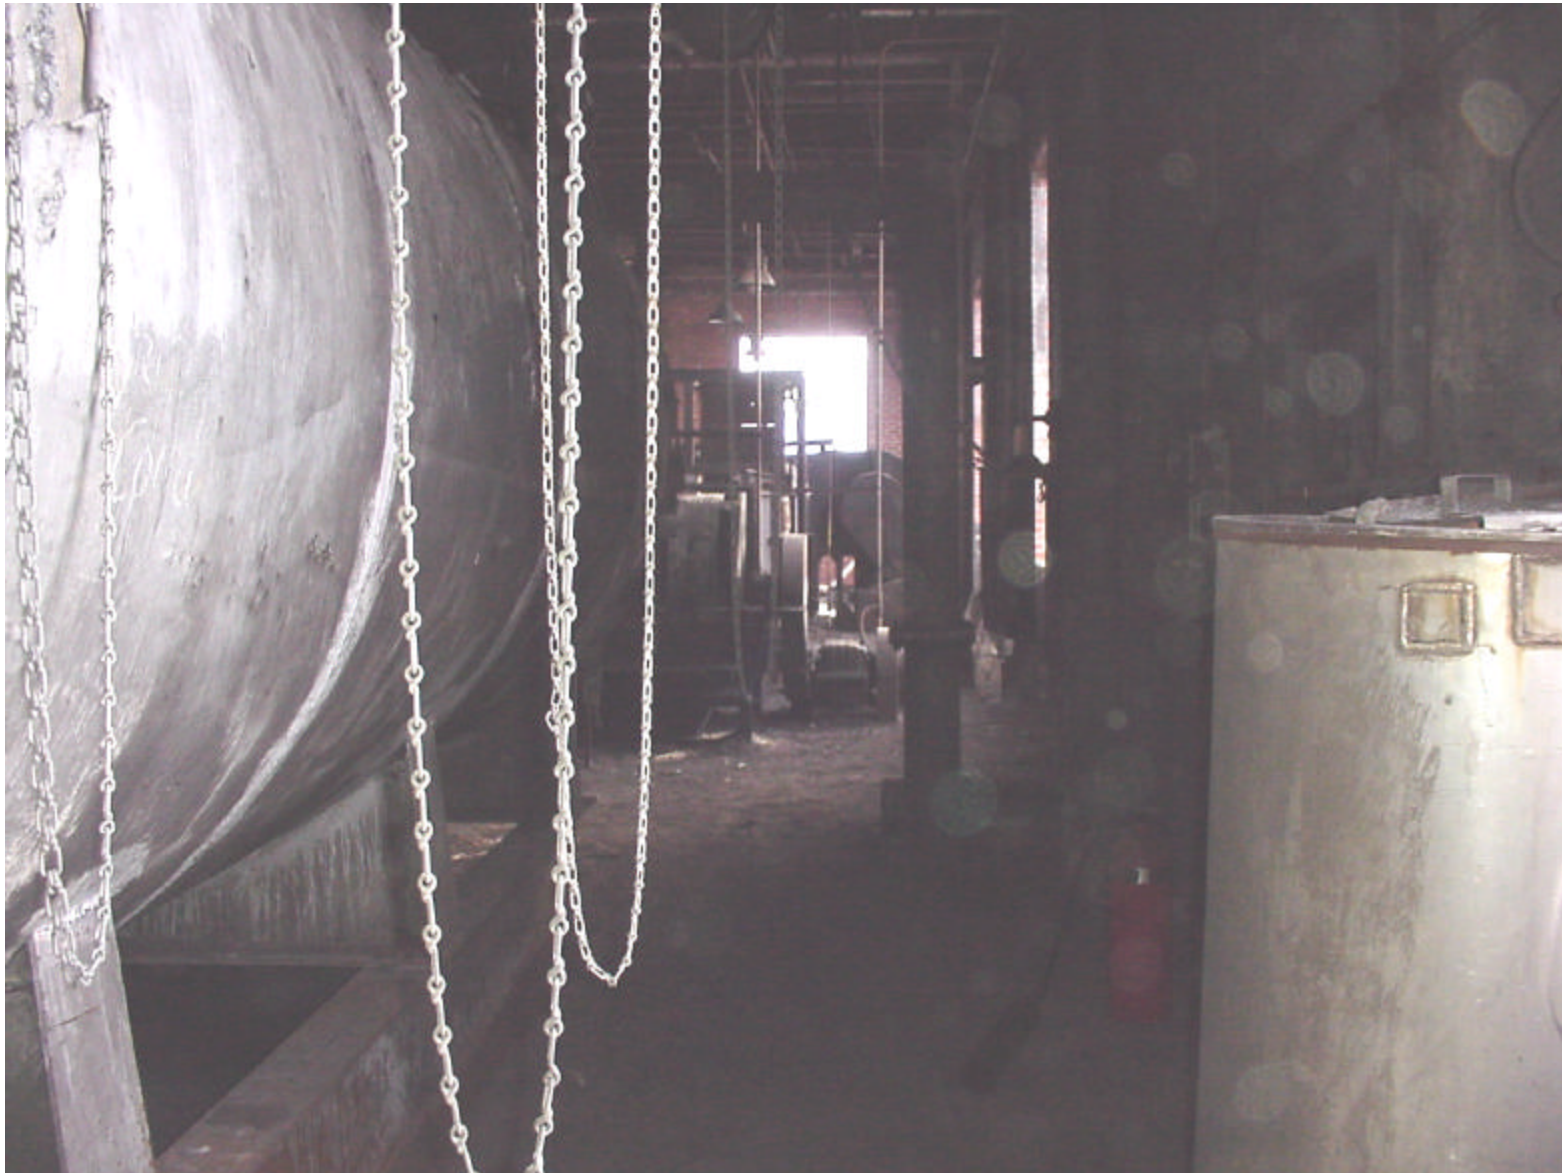
Photograph ID	Date Taken	Section #	Room #	Room Description	Description
MVC-701		VII	7.06H	5th Floor Boiler House	Looking south from northwest corner of room

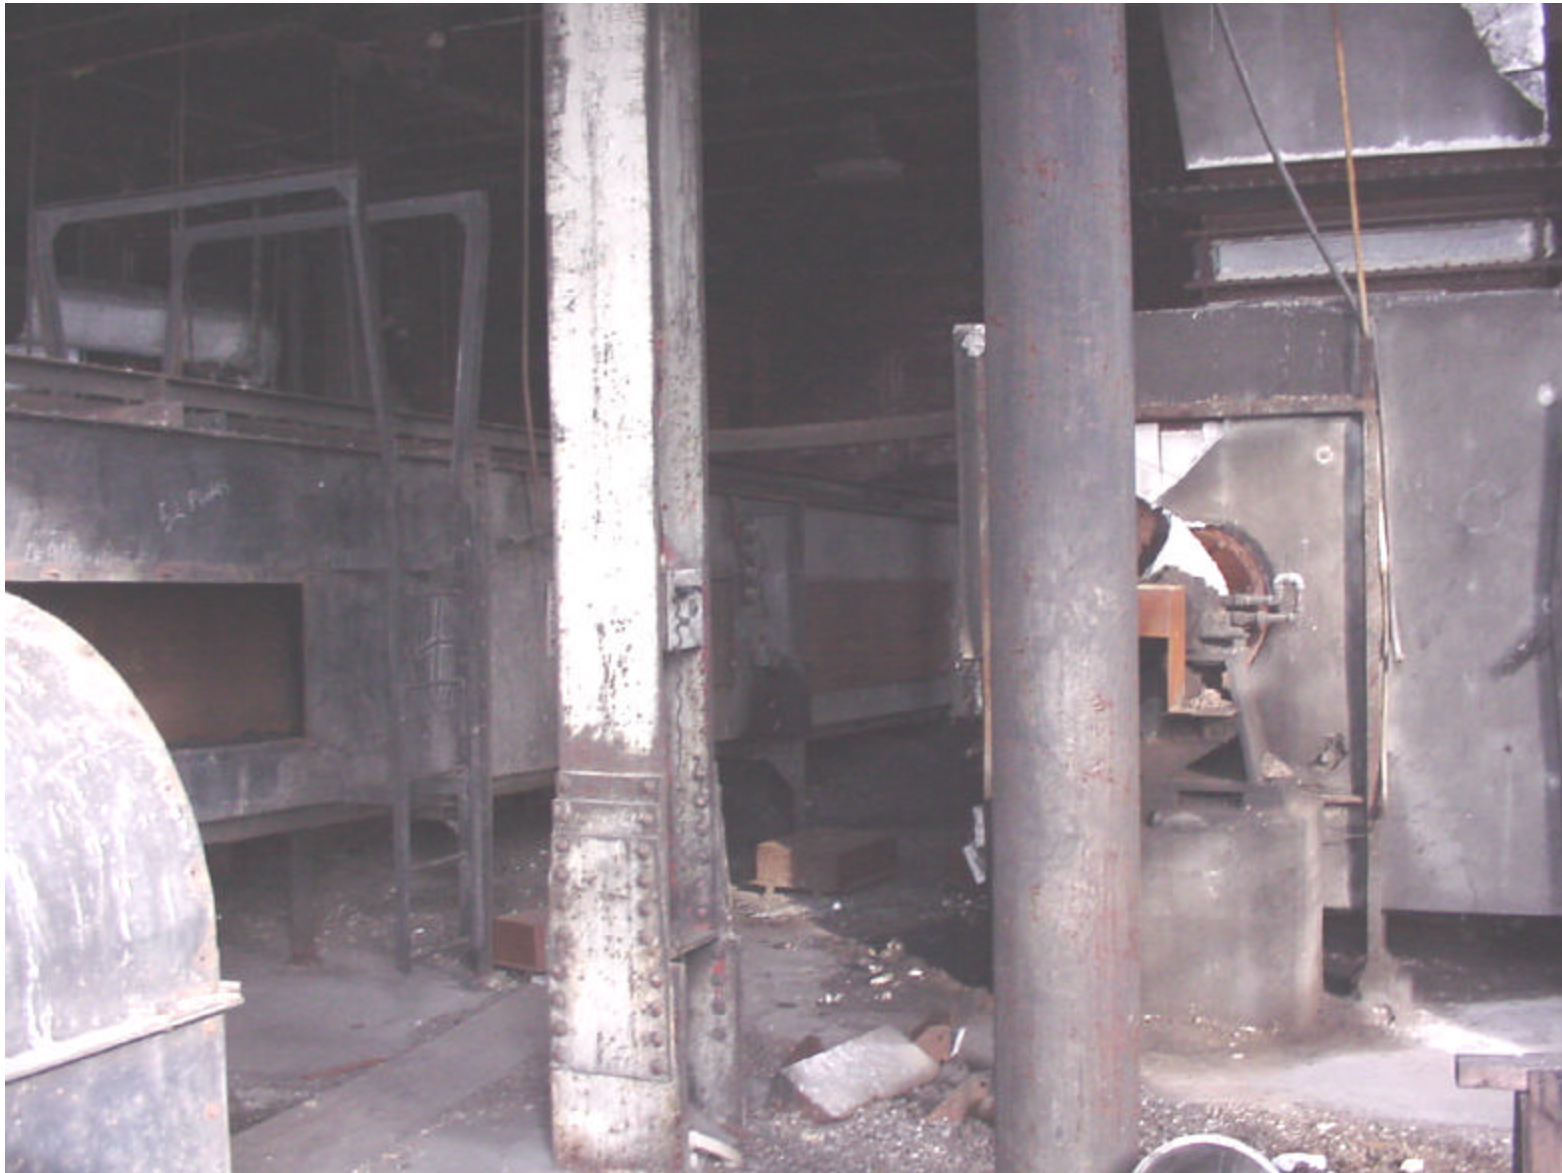
Photograph ID	Date Taken	Section #	Room #	Room Description	Description
MVC-703		VII	7.06H	5th Floor Boiler House	Looking northeast from southwest corner of room

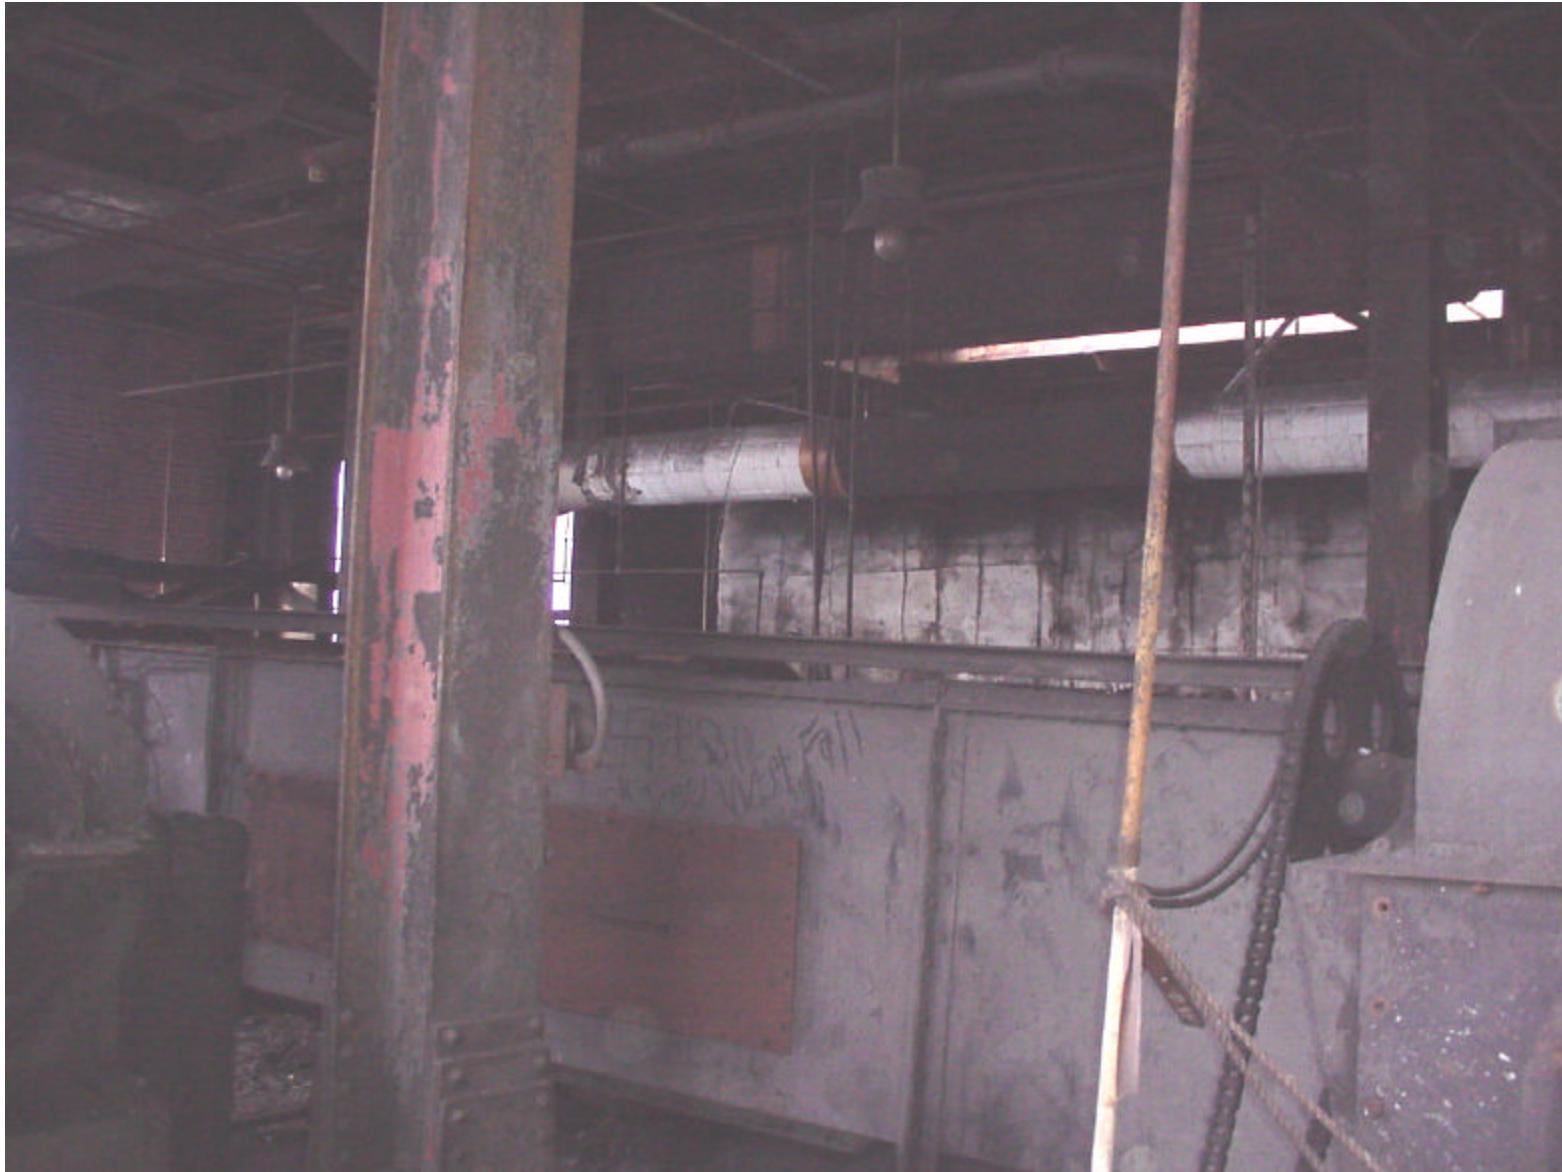
Photograph ID	Date Taken	Section #	Room #	Room Description	Description
MVC-704		VII	7.06H	5th Floor Boiler House	Looking northwest from southeast corner of room

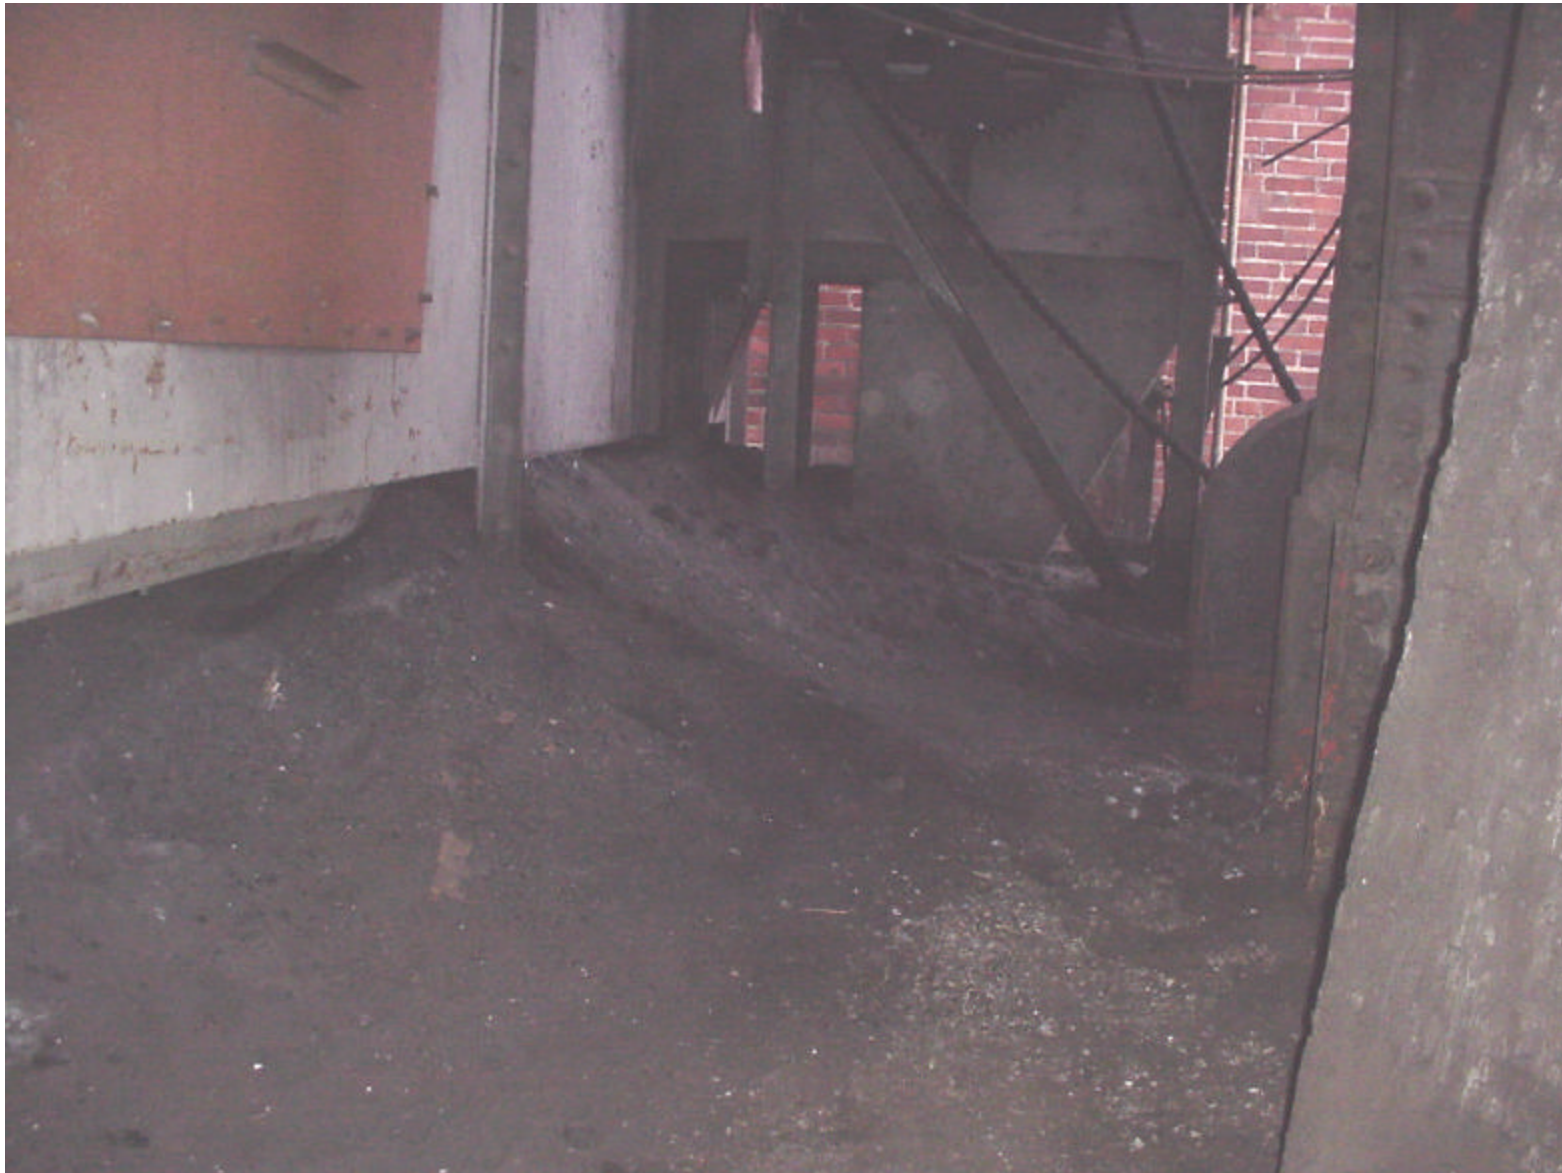
Equipment Description:	<u>Blowers (NE corner), miscellaneous boiler machinery.</u>
Tank(s)/containers:	<u>None.</u>
Chemical Contamination:	<u>Coal dust and oil stains. Coal dust is up to 3 inches deep.</u>

Photograph ID	Date Taken	Section #	Room #	Room Description	Description
MVC-705		VII	7.06H	5th Floor Boiler House	Coal dust on floor in southeast corner of room

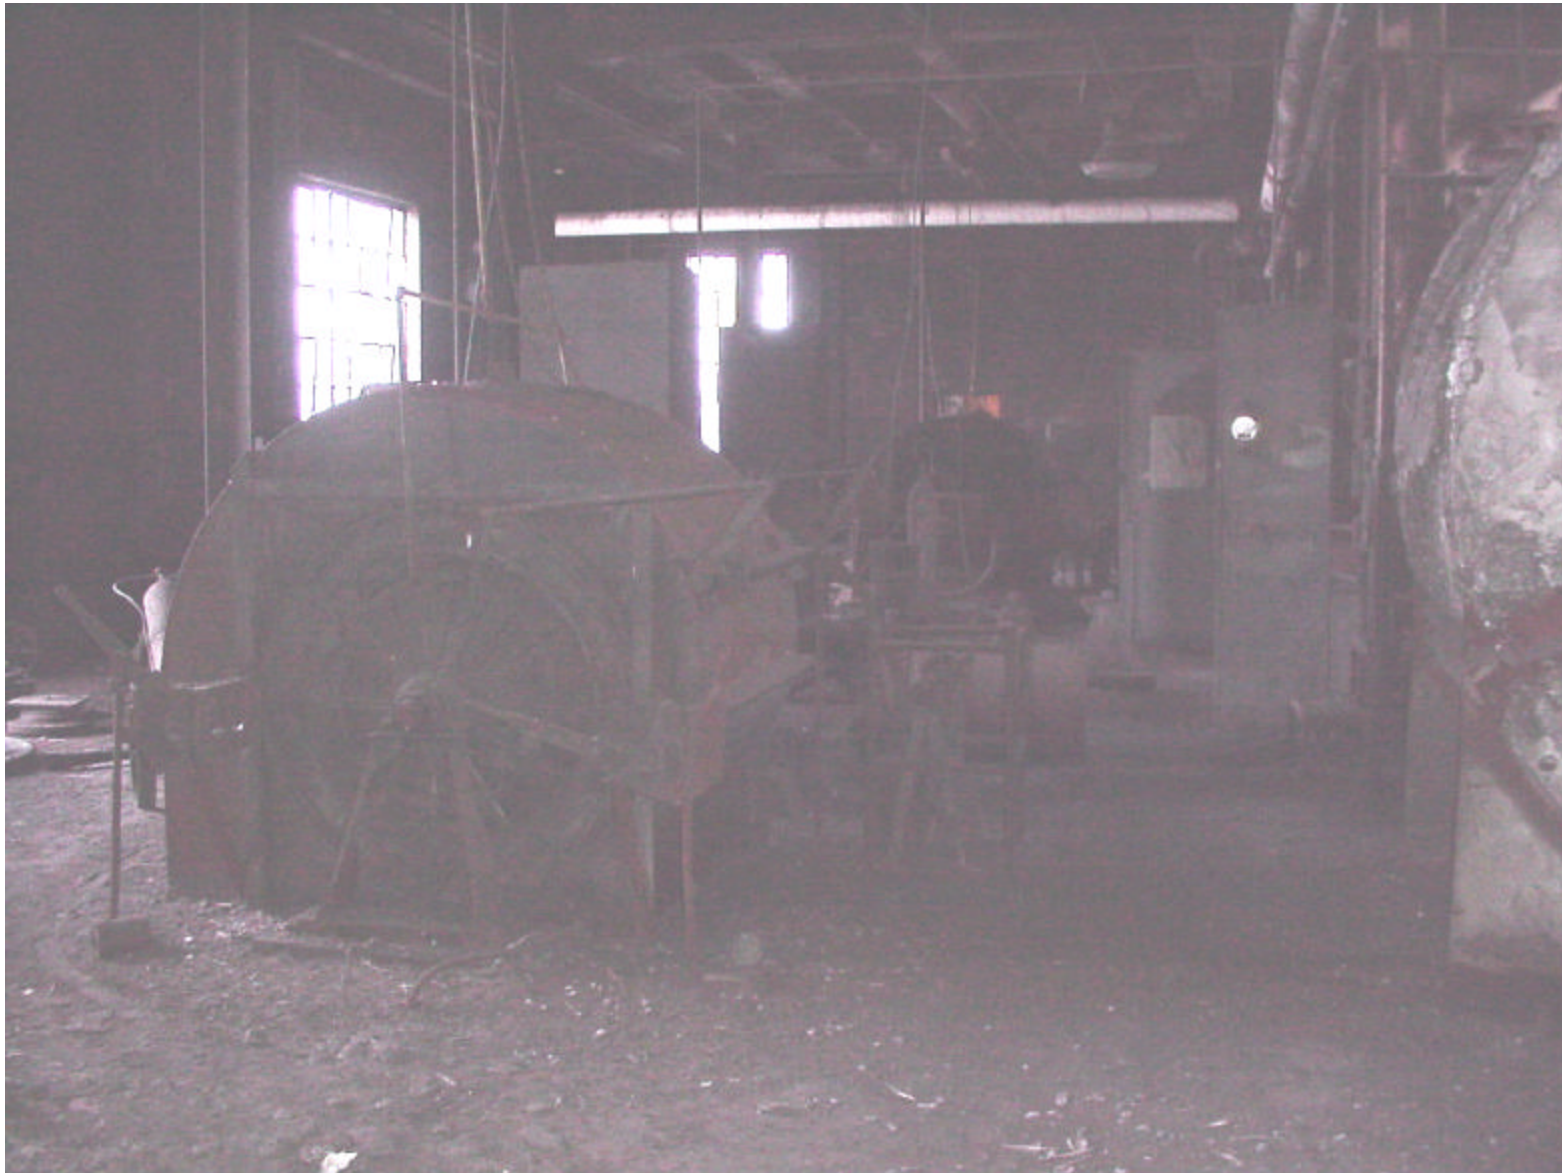
Photograph ID	Date Taken	Section #	Room #	Room Description	Description
MVC-706		VII	7.06H	5th Floor Boiler House	Boiler unit in northeast corner of room

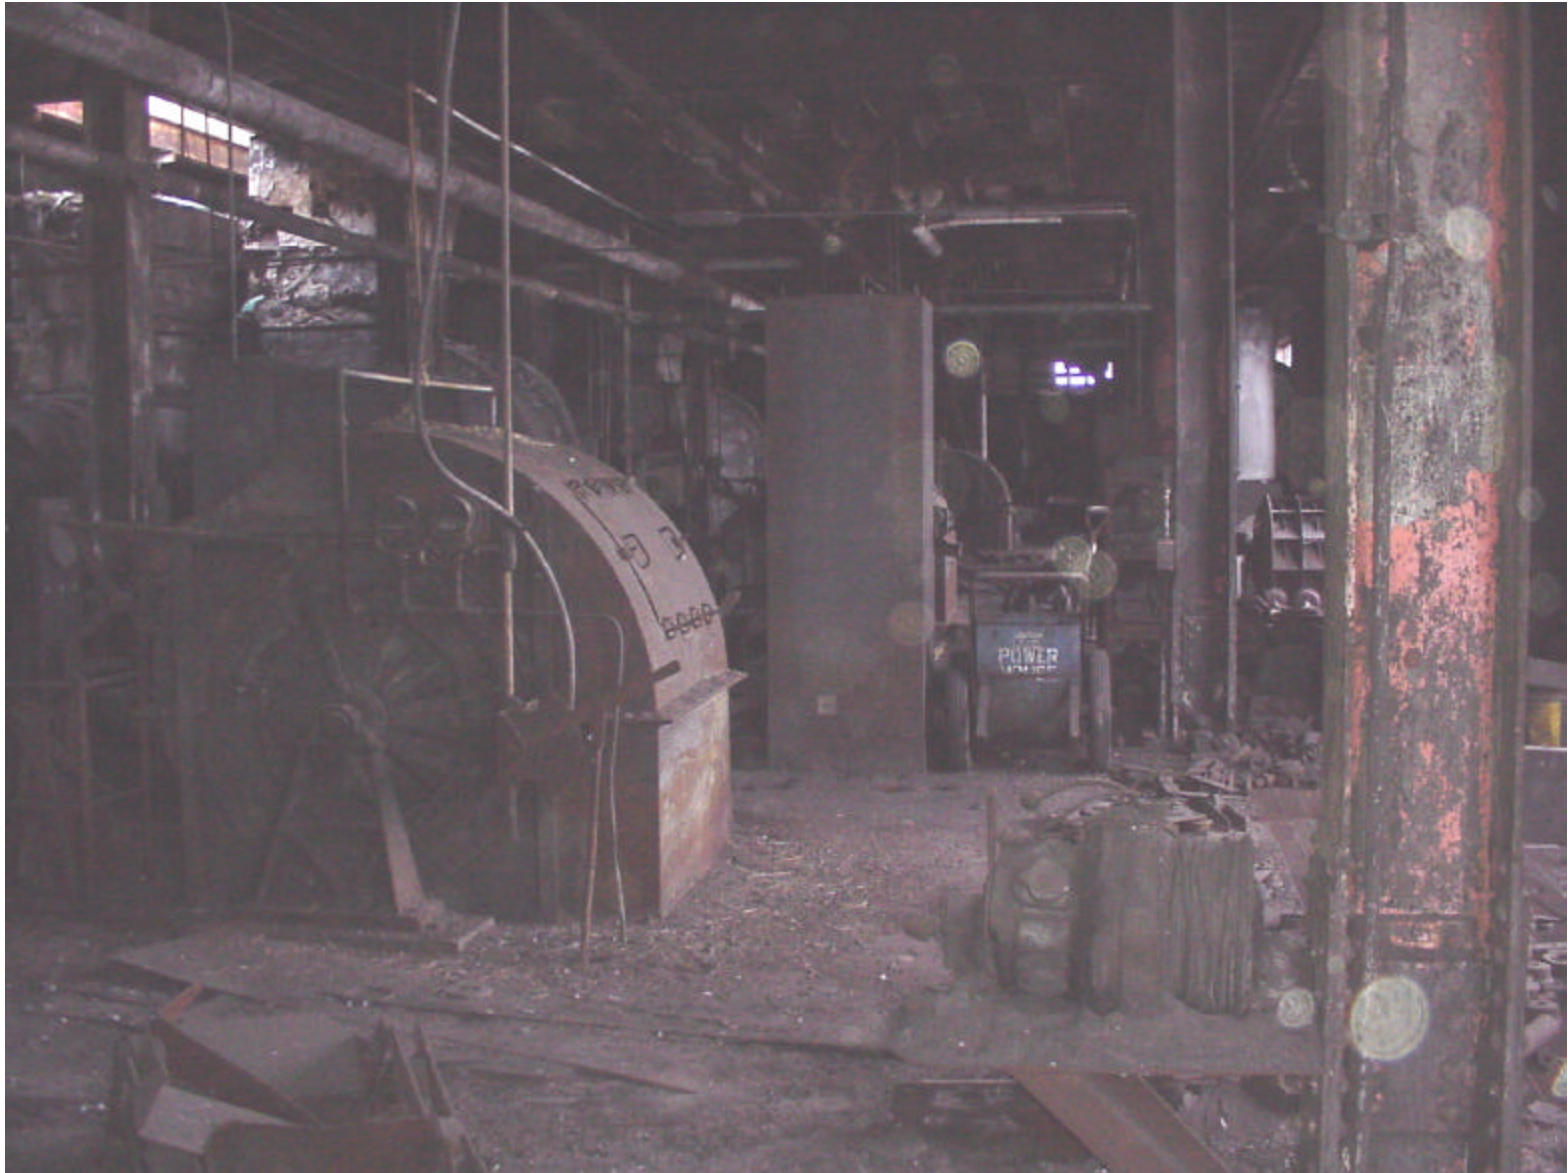
Photograph ID	Date Taken	Section #	Room #	Room Description	Description
MVC-707		VII	7.06H	5th Floor Boiler House	Looking east from northwest corner of room

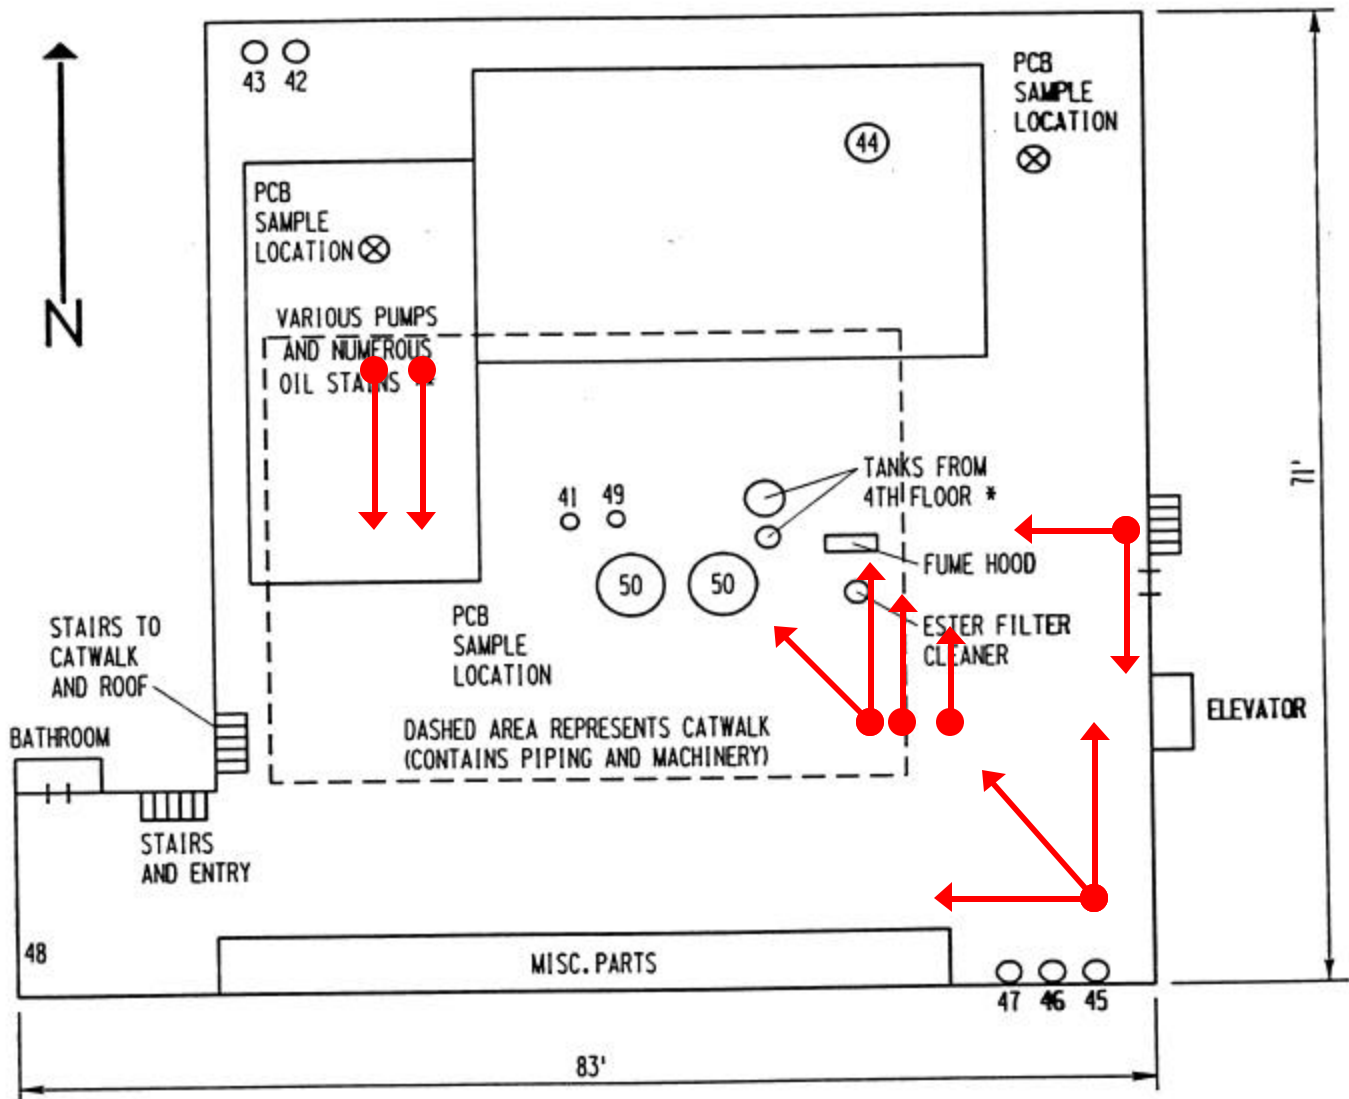
\* EXTENDS UP CATWALK

\*\* ALL PUMPS HAVE PANS W/OIL IN THEM

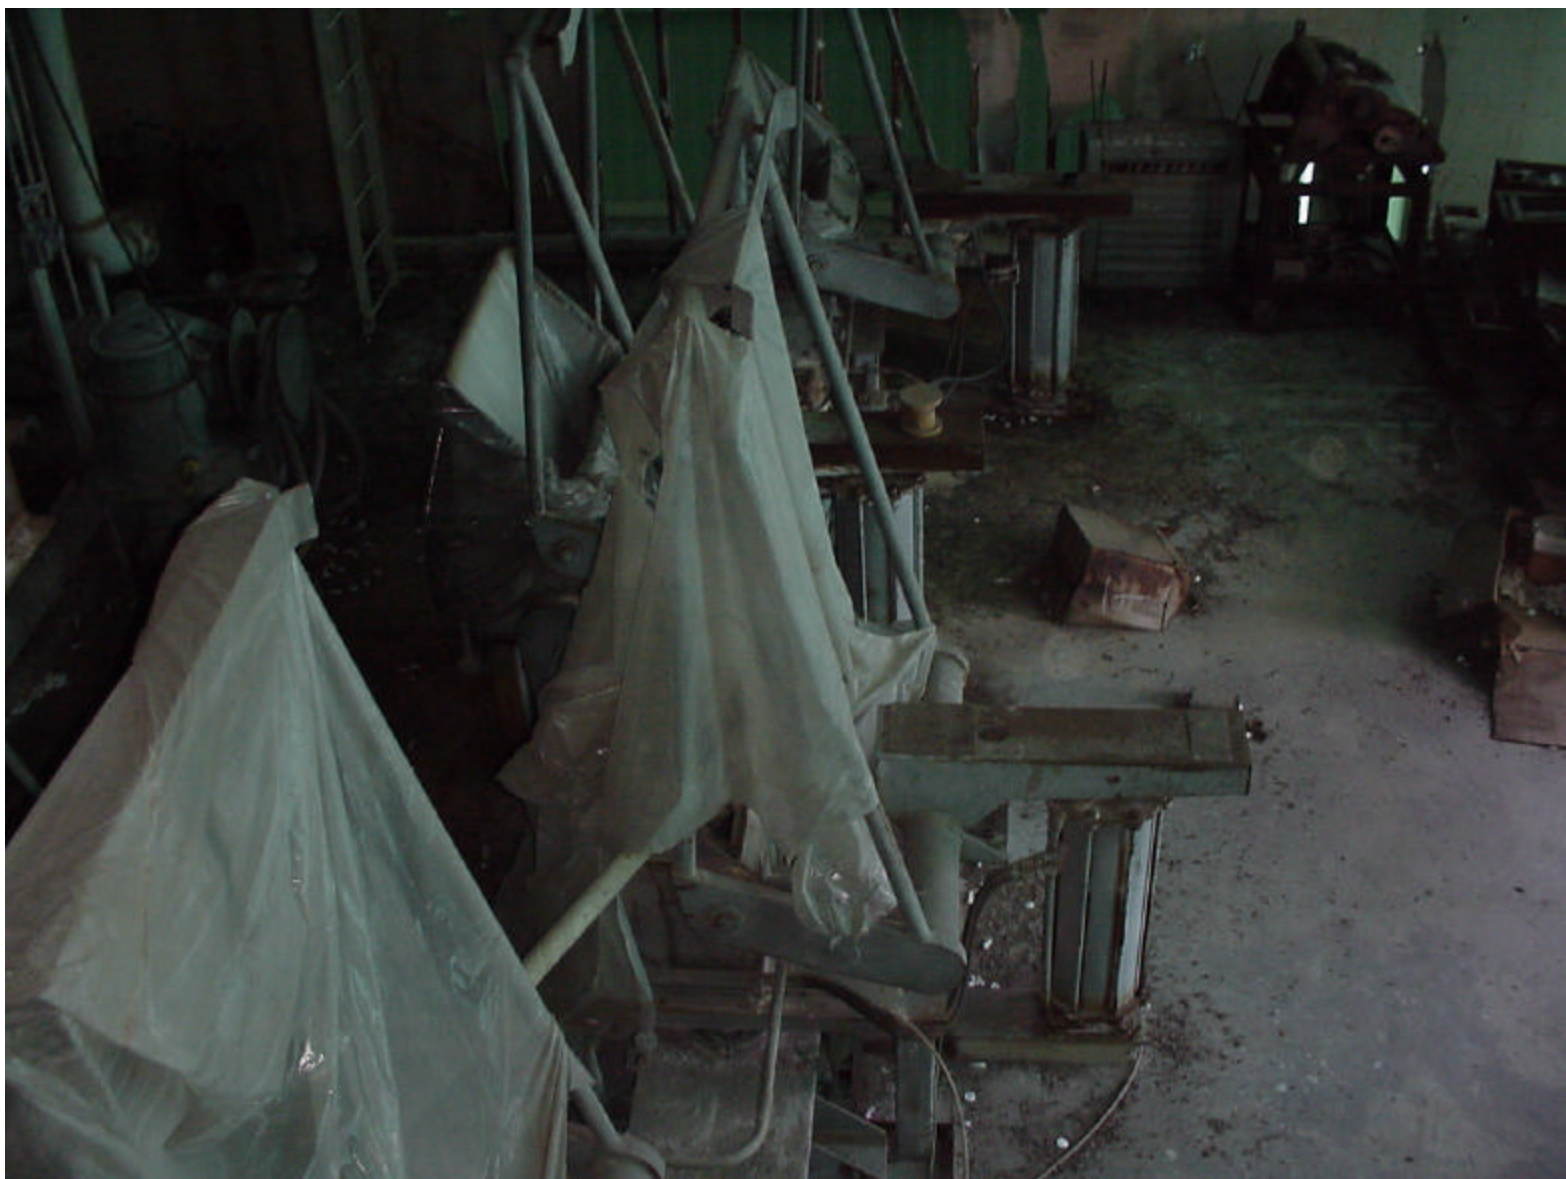
Photograph ID	Date Taken	Section #	Room #	Room Description	Description
MVC-1110	1/19/00	I	1.05F	Polymer Plant	General view of floor looking north from the 5th floor mezzanine

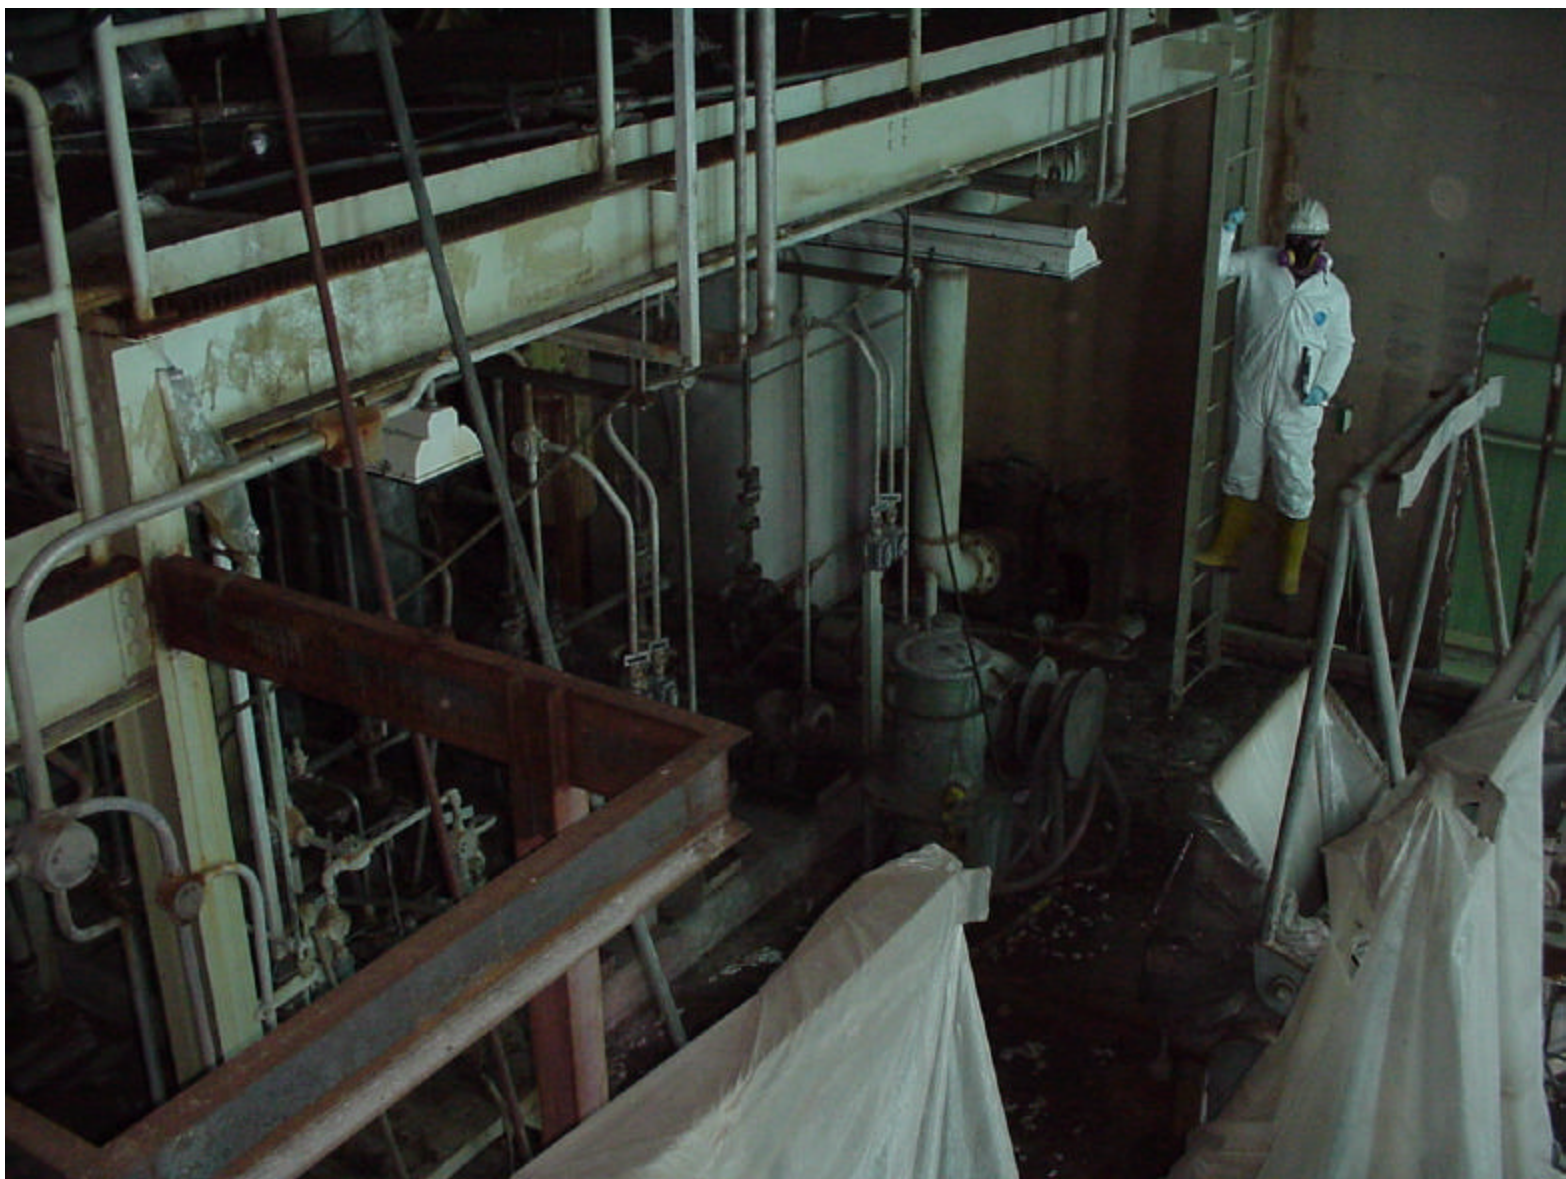
Photograph ID	Date Taken	Section #	Room #	Room Description	Description
MVC-1111	1/19/00	I	1.05F	Polymer Plant	General view of floor looking north from the 5th floor mezzanine

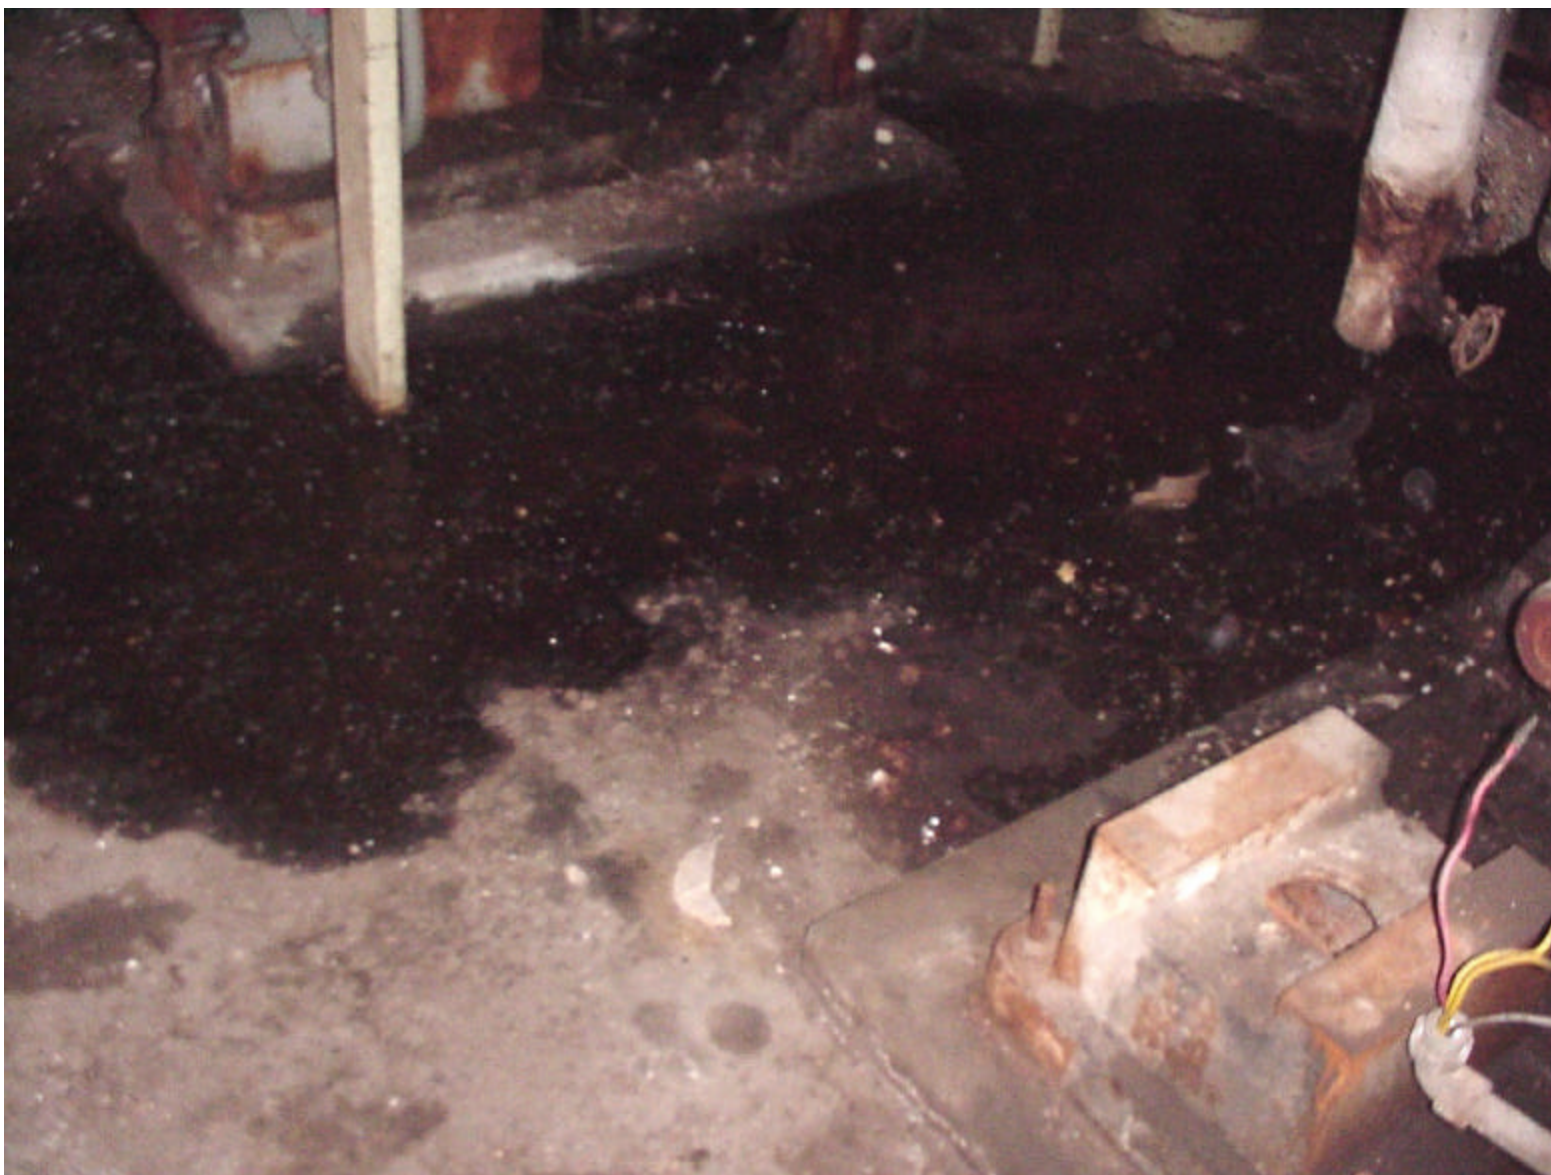
**Additional Comments:** One-sixth (1/6) of the total floor area is stained or contains free product. The floor also has significant amounts of pigeon dung. There are 72 possible PCB light ballasts, 5 30-cu yd dumpsters of miscellaneous debris, and 4000 ft of possible ACM wrapped pipe.

Photograph ID	Date Taken	Section #	Room #	Room Description	Description
MVC-211	11/22/99	I	1.05F	Polymer Plant 5th Floor	Residual oil from leaking pipe on the floor in the southwest corner of room.

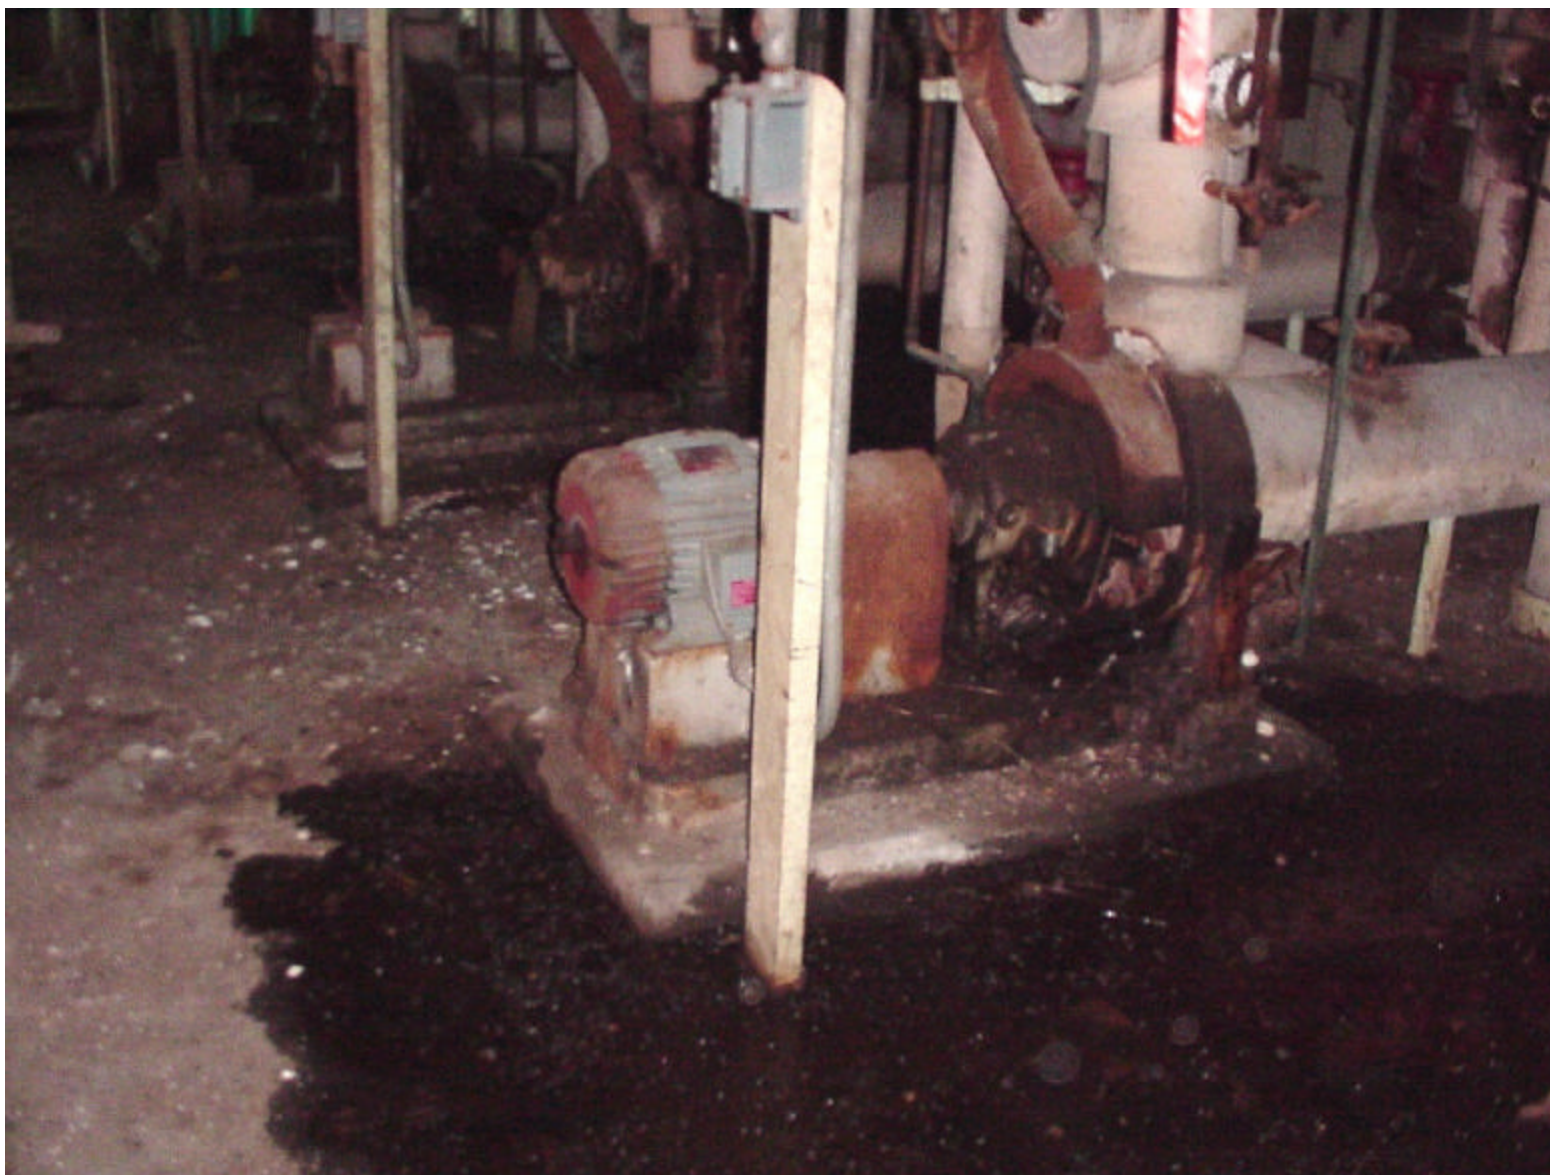
Photograph ID	Date Taken	Section #	Room #	Room Description	Description
MVC-212	11/22/99	I	1.05F	Polymer Plant 5th Floor	Residual oil and oily staining on the floor.
